Ford Econoline E350 E450 vent switch stuck on defrost

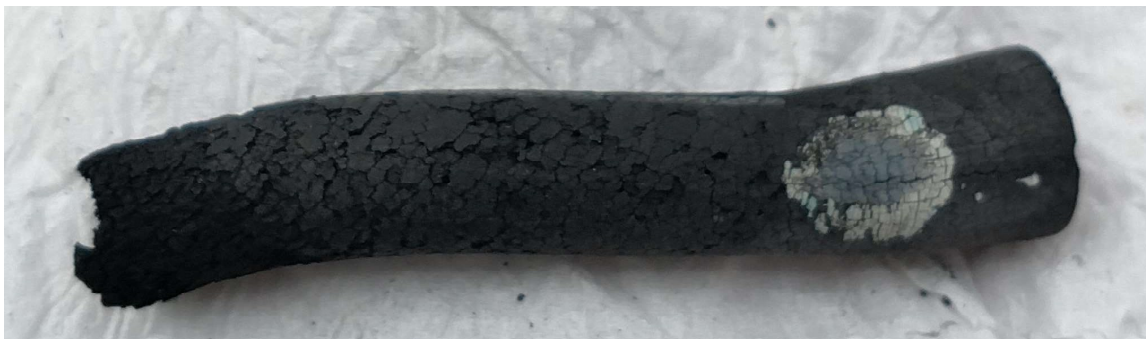
Failed 3-inch vacuum line located between check valve and vacuum reservoir buried in the air box behind the air conditioner components on the engine-side of the firewall.

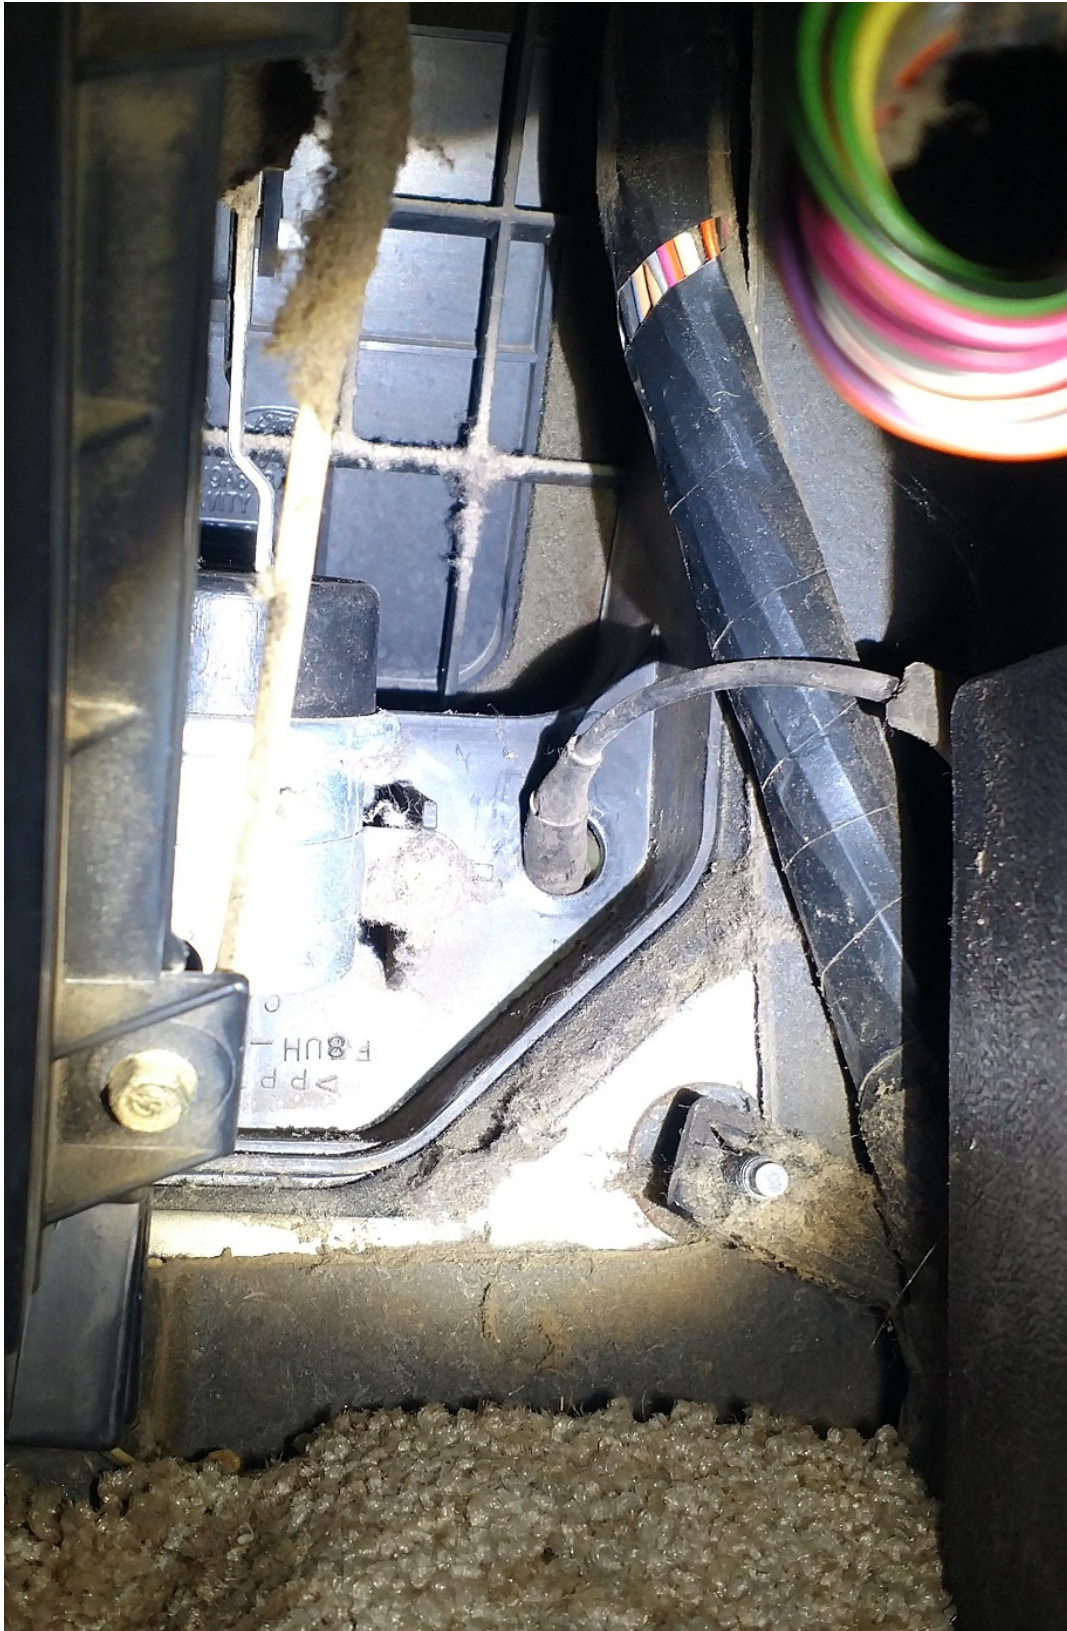
This shows the vacuum line pulled into the cab with the end of the control line attached to the check valve on the other side of the plastic air box. Inspect, but don't disconnect this line.

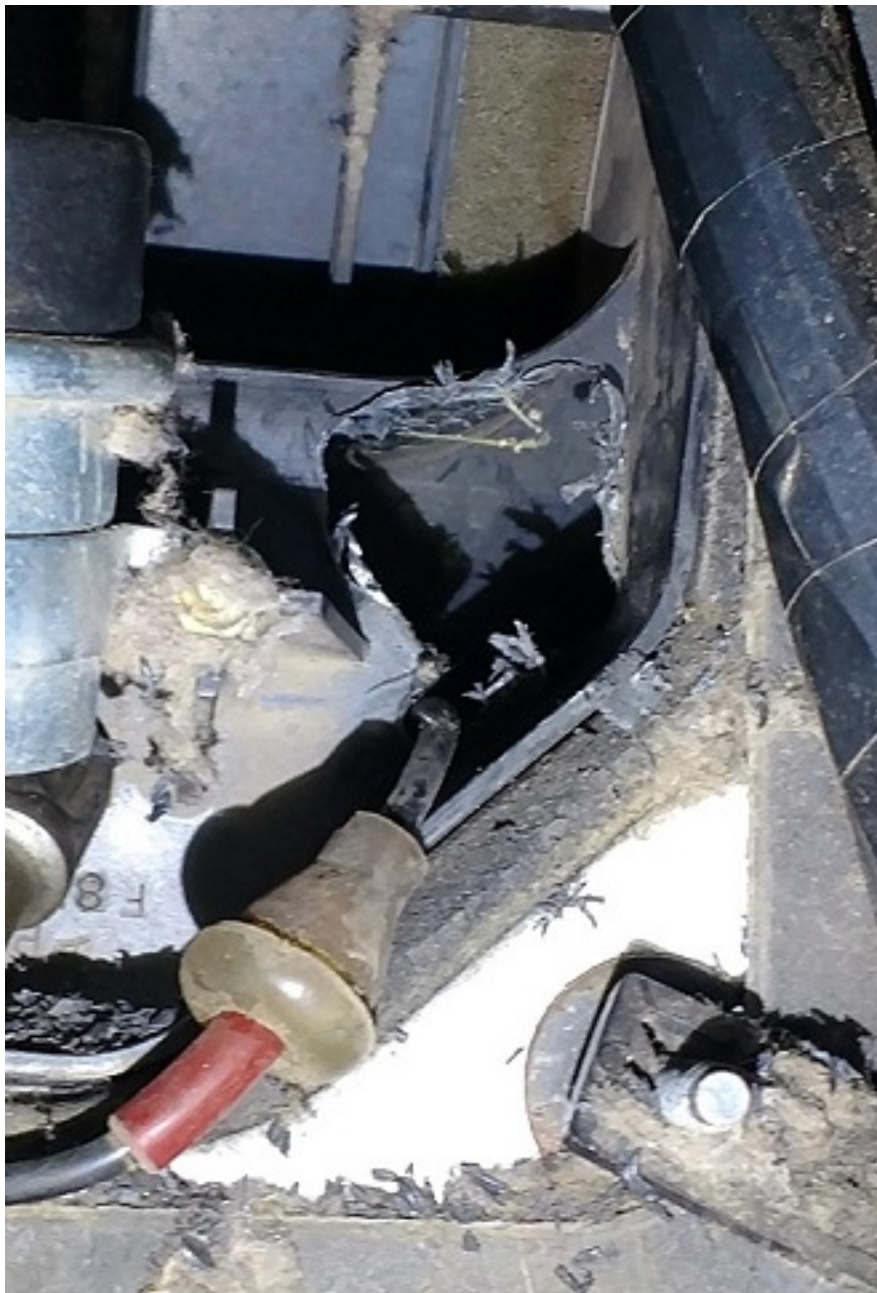
This shows the vacuum line entering the cab with the grommet and red expansion sleeve hanging out of the enlarged hole in the air box. The view is from the passenger side floorboard.
